CONNECTICUT RIVER

AFTER CHANGES

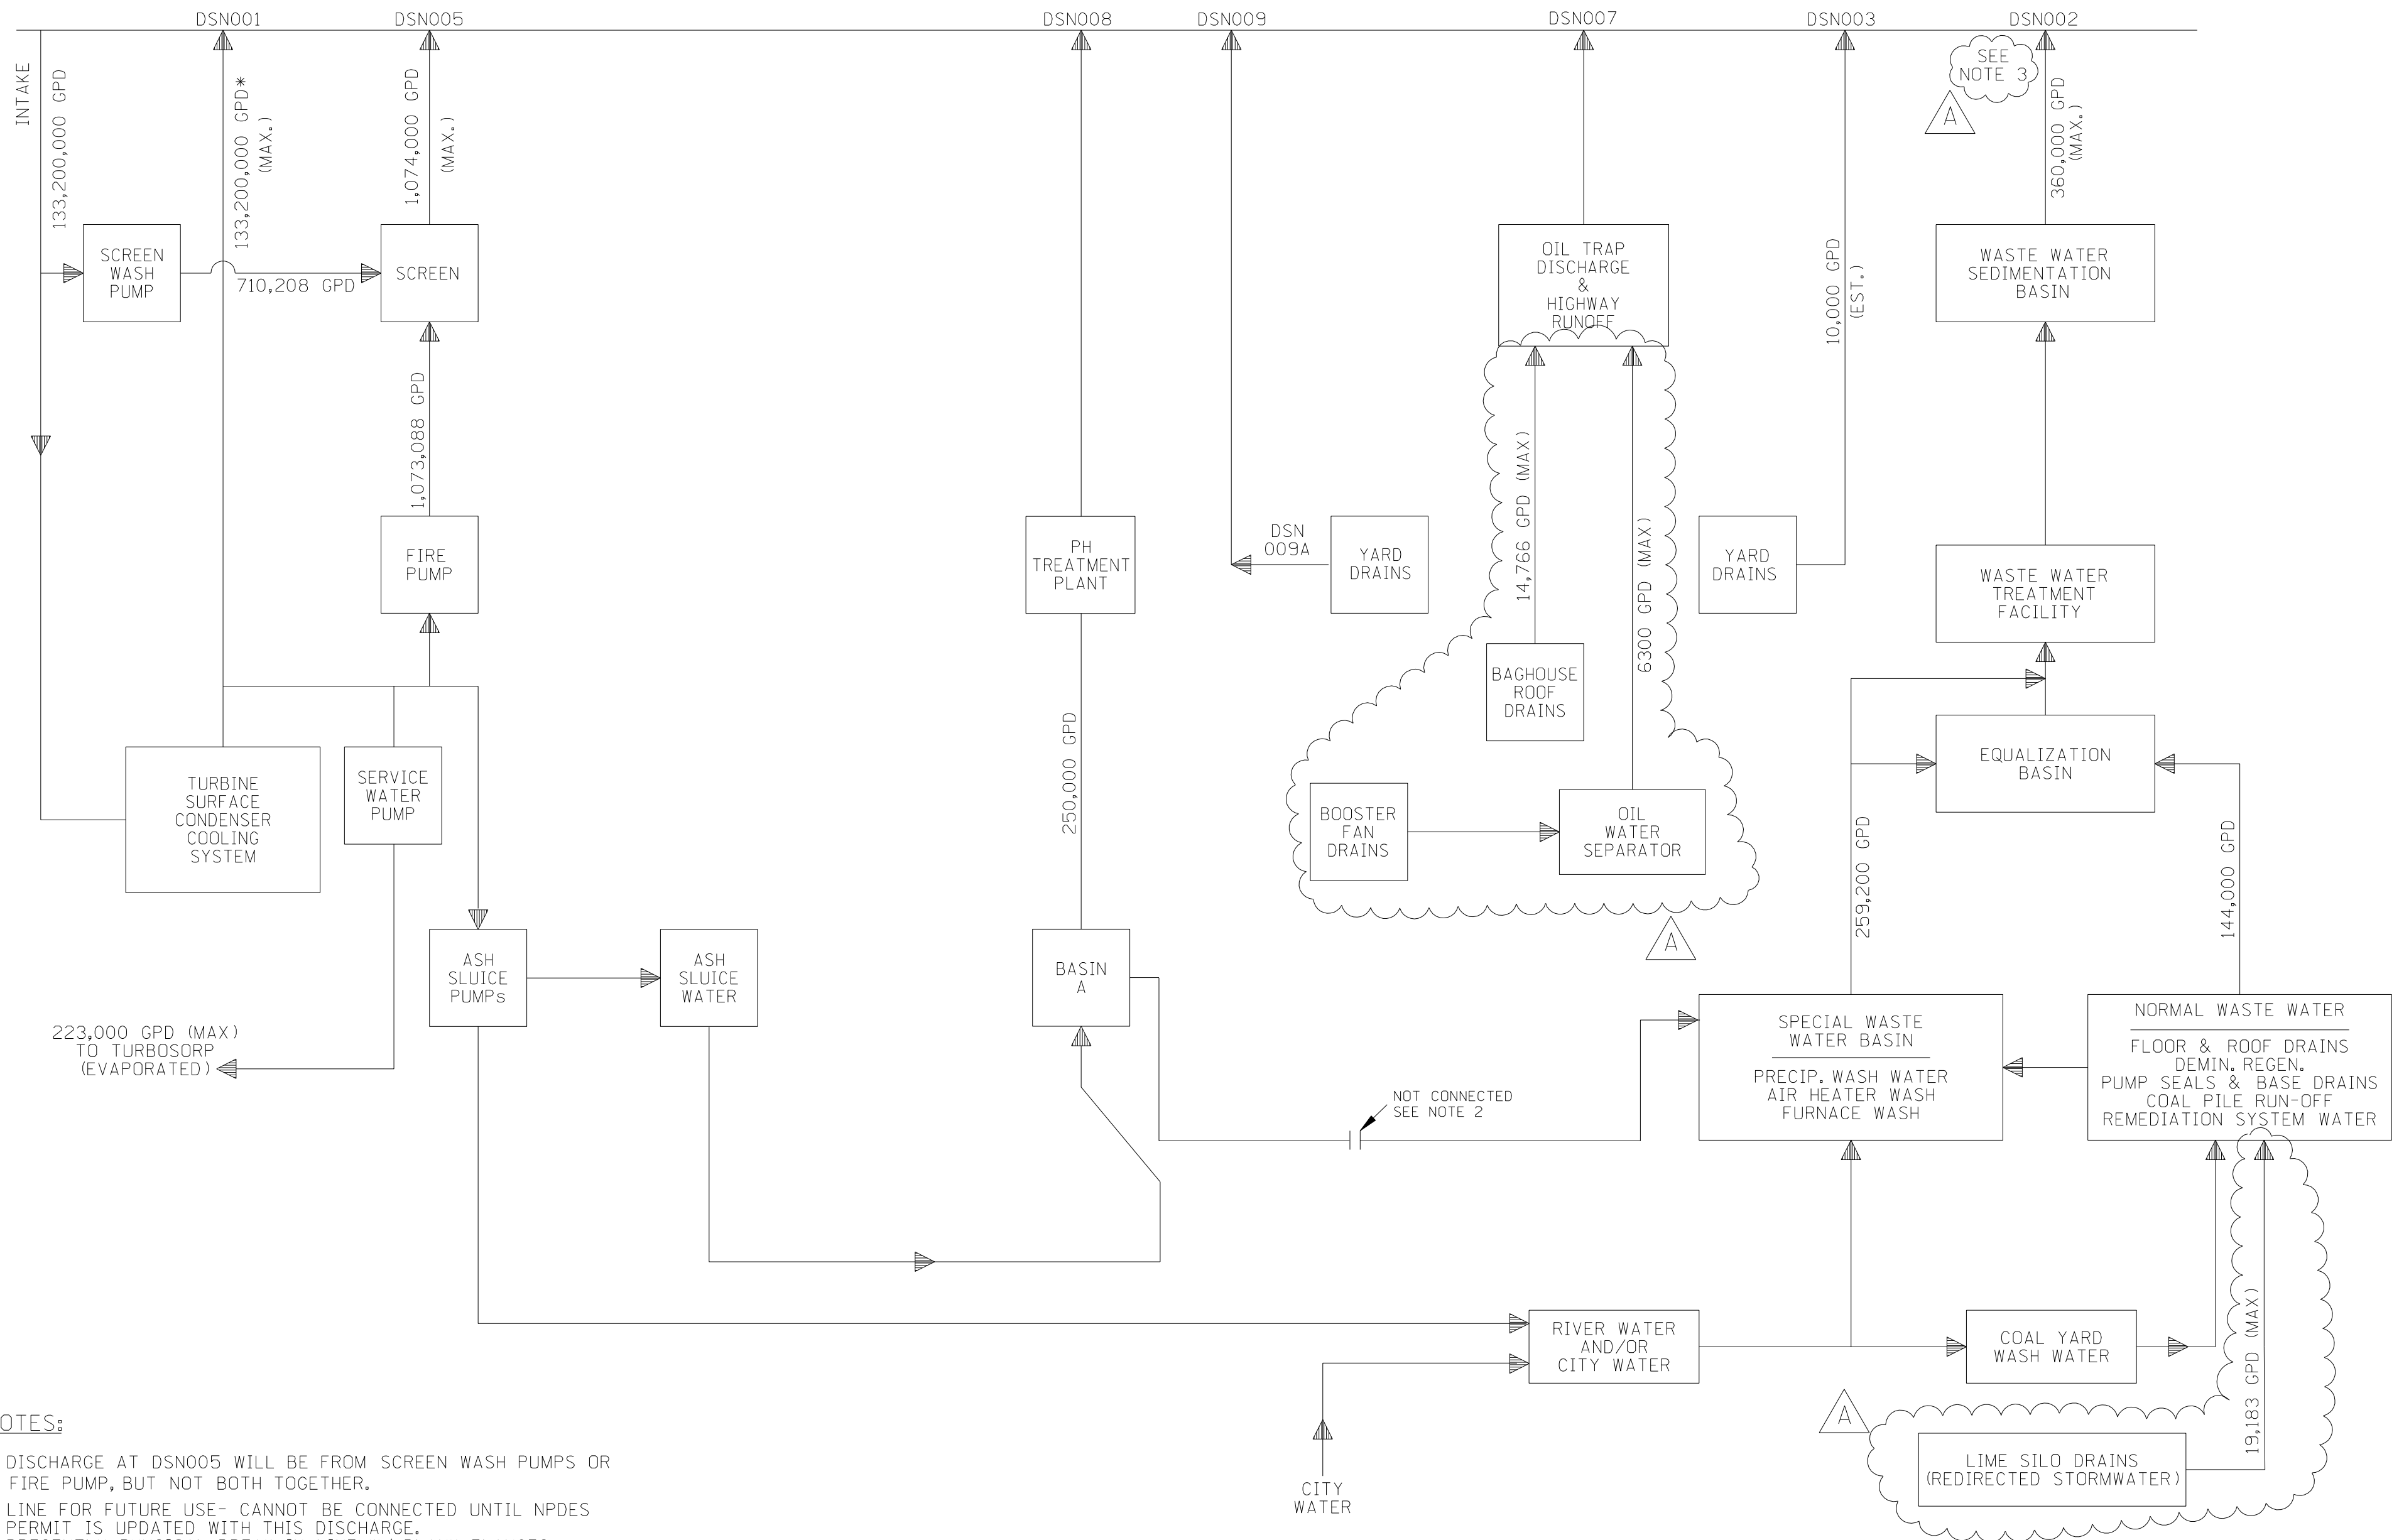
1. DISCHARGE AT DSN005 WILL BE FROM SCREEN WASH PUMPS OR FIRE PUMP, BUT NOT BOTH TOGETHER.
2. LINE FOR FUTURE USE- CANNOT BE CONNECTED UNTIL NPDES PERMIT IS UPDATED WITH THIS DISCHARGE.
PRESENTLY PHYSICAL BREAK IN LINE W/ BLANK FLANGES.
3. LIME SILO AREA DRAINAGE NOW DISCHARGED TO DSN002 ALSO FLOW REDUCED BY BOOSTER FAN AREA & BAGHOUSE ROOF DRAINS NOW DISCHARGE TO DSN007.

* FLOW WHEN FIRE PUMP, REFLECTING POOL AND
ASH SLUICE PUMPS ARE OUT OF SERVICE.

* * FLOW OF 250,00 GPD WILL BE FROM DSN008 OR DSN005, NOT BOTH TOGETHER
